**RESULTS OF INDEPENDENT LABORATORY TESTING  
FOR TASK FORCE TIPS, INC.®  
SALT SPRAY EXPOSURE TESTING PER  
5% ASTM B117 1000 HOURS**

CHARLES C. KAWIN COMPANY  
METALLURGICAL LABORATORIES

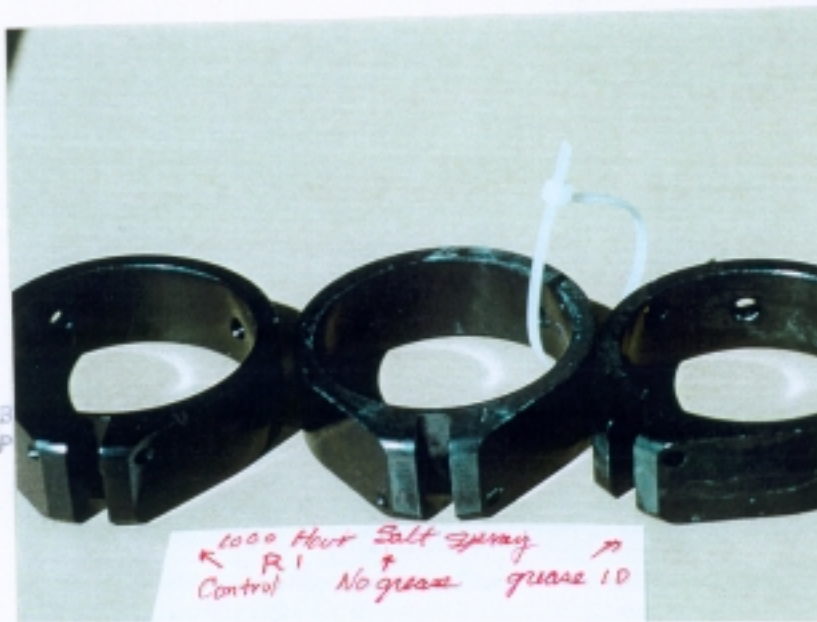
SAMPLE R1 #555 Collar  
.001 Hc Black dye Nickel Acetate (meas .0021)  
accurate

AFTER 120 HOURS OF SALT SPRAY TESTING BOTH THE GREASED AND UNGREASED RINGS EXHIBITED VERY LIGHT WHITE CORROSION PRODUCTS. AFTER 1000 HOURS OF EXPOSURE BOTH SAMPLES EXHIBITED A FEW AREAS OF LIGHT WHITE CORROSION

ID of grease sample nearly by thin film of residue on ID

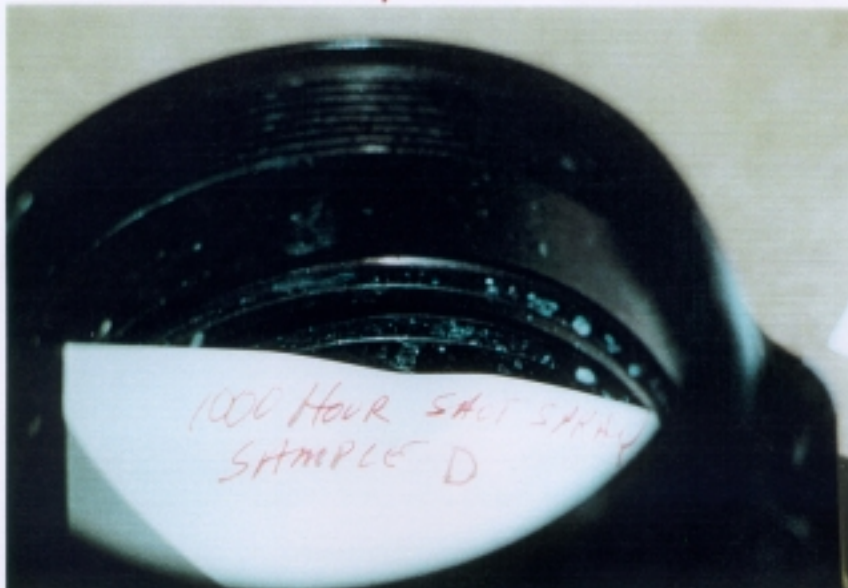
D

AFTER 1000 HOURS OF CONTINUOUS SALT SPRAY TESTING, PERFORMED IN ACCORDANCE WITH ASTM B117, THERE WAS VISIBLE EVIDENCE OF VERY LIGHT TO LIGHT WHITE CORROSION PRODUCTS ON THE SUBMITTED SAMPLE.

no pits. products of corrosion appear on surface, but scrape off w/ knife. Inside looks much worse than outside. Some rust staining from stainless parts.

No evidence of corrosion at Rubber/Alum interface. Rubber is OK

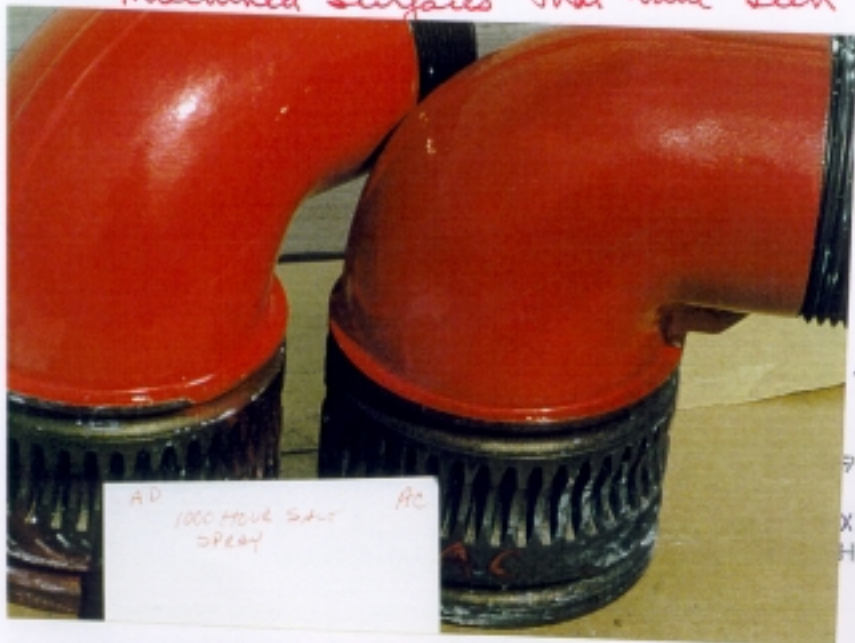
AC *K330 EL Bow*  
*356-T6 Alum*  
*.002 Hard Coat Nickel Acetate seal*  
*Standard Amer Red Powder coat*

AFTER 1000 HOURS OF CONTINUOUS SALT SPRAY EXPOSURE PER ASTM B117 THERE WAS VISIBLE EVIDENCE OF LIGHT WHITE CORROSION PRODUCTS ON THE UNPAINTED SURFACES. THIS CORROSION WAS DETECTED AFTER 27 DAYS (648 HOURS).

*EXTERIOR + interior Powder coated Surfaces are excellent.*  
*There are a number of white spots on the exposed machined surfaces that have been Hard coated, but*

*of corrosion at or peeling back in Photo at bend*

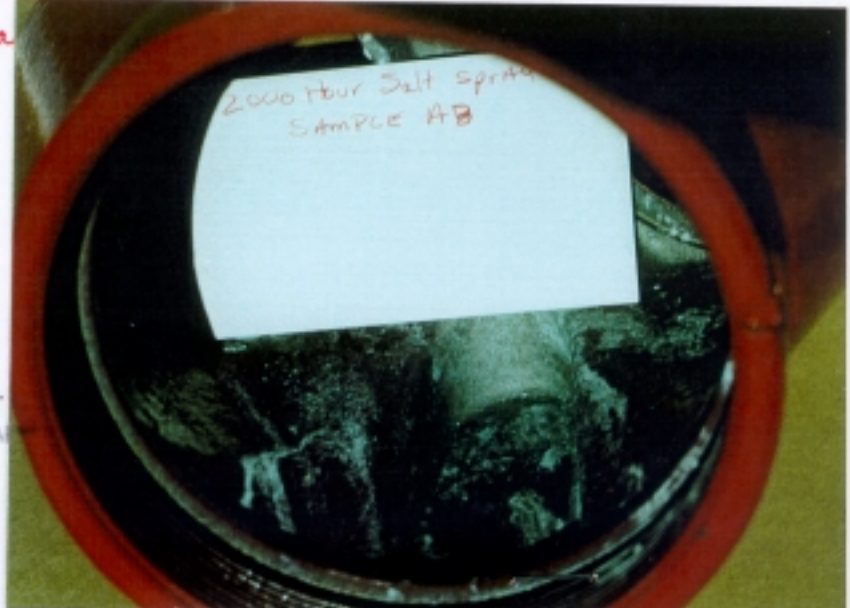
SAMPLE AB X712 XF 2 inlet Base  
HC .002 Nukel Acetate Seal  
H 09139/PA 9202/9 Polyester PC (Amer Red)

THIS SAMPLE EXHIBITED LIGHT WHITE CORROSION PRODUCTS PRIOR TO THIS SALT SPRAY EXPOSURE. AFTER 648 HOURS OF EXPOSURE SOME MODERATE AREAS OF WHITE CORROSION WERE VISIBLE ON THE INSIDE SURFACES. A FEW AREAS OF WHITE CORROSION PRODUCTS ARE ALSO VISILBE ON THE PAINTED SURFACES.

*Very little change on inside.  
The area that was scratched shows no  
corrosion. There is corrosion at  
The HSBG and shoulder of inlet on OD.  
These surfaces were powder  
coated. The rest of  
exterior surface  
goal as new*

*Corrosion*

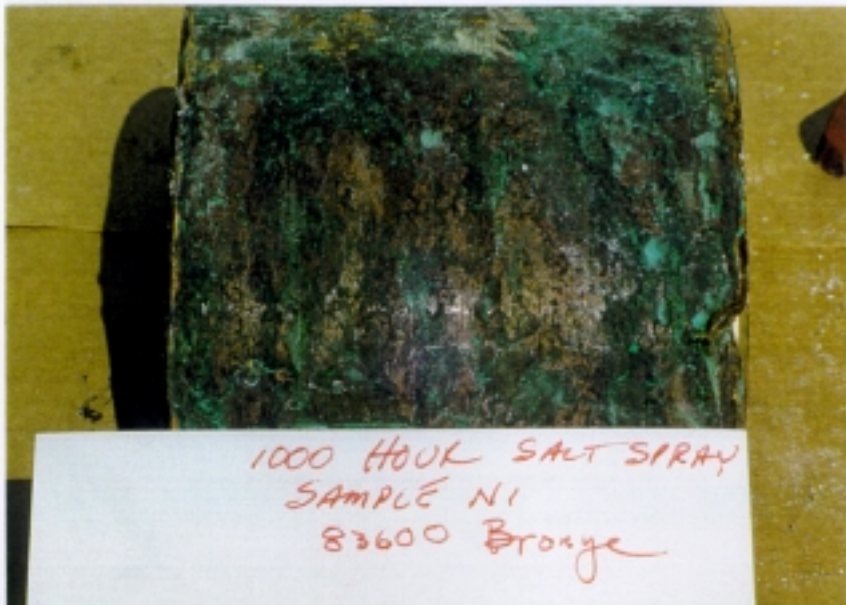
N1 *83600 Bronze Sample*  
*Base*  
*X110 casting Sample in bronze*  
SALT SPRAY TEST

AFTER 1000 HOURS OF CONTINUOUS SALT SPRAY EXPOSURE PER ASTM B117 THERE WAS EVIDENCE OF LIGHT TO MODERATE AMOUNTS OF GREEN CORROSION PRODUCTS ON THIS SPECIMEN. CORROSION BEGAN TO OCCUR AFTER 5 DAYS (120 HOURS).

*OD worse than ID surface is nearly all Darkened and is about 25% green. No pitting evident.*

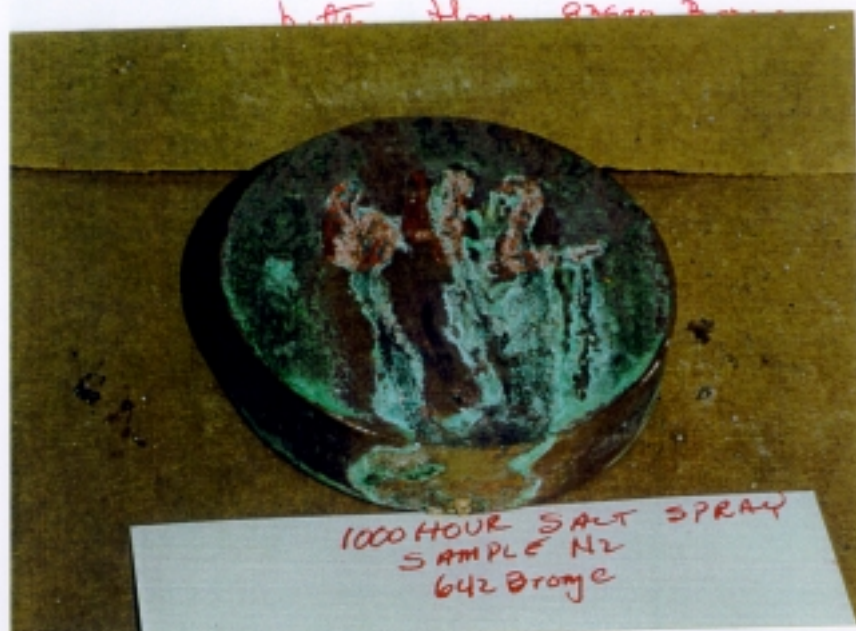
*1000 HOUR SALT SPRAY  
SAMPLE N2  
642 Bronze*

AFTER 1000 HOURS OF CONTINUOUS SALT SPRAY EXPOSURE PER ASTM B117 THERE WAS A LIGHT TO MODERATE AMOUNT OF GREEN AND WHITE CORROSION PRODUCTS ON THE SURFACES OF THIS SAMPLE. CORROSION PRODUCTS WERE DETECTED AFTER 7 DAYS (168 HOURS).

*Sample has dark areas + green streaks.  
One can tell it is still Bronze. looks much  
better than 83600 Bronze*

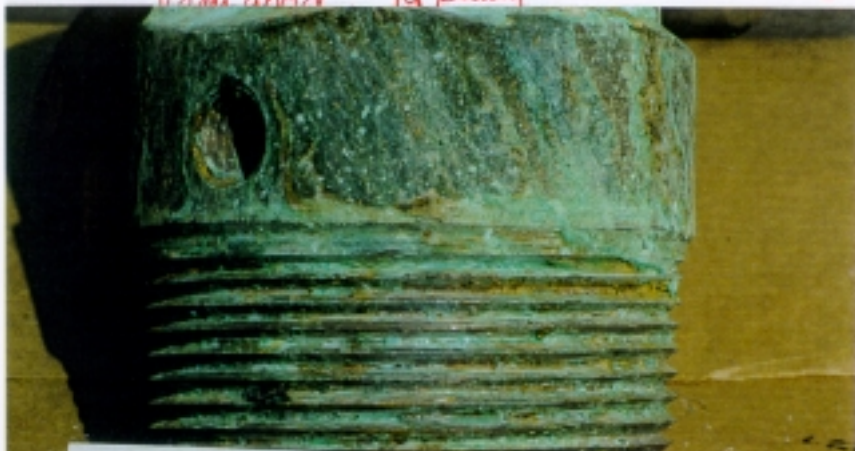
*1000 HOUR SALT SPRAY*  
*955 Bronze*  
*SAMPLE N3*

AFTER 1000 HOURS OF CONTINUOUS SALT SPRAY EXPOSURE PER ASTM B117  
THERE WAS HEAVY AMOUNTS OF GREEN CORROSION PRODUCTS PRESENT.  
THERE WAS ALSO A MODERATE AMOUNT OF RED CORROSION PRODUCTS.  
CORROSION BEGAN TO OCCUR AFTER 7 DAYS (168 HOURS)

*mostly green & thick Build up on <sup>OD</sup> threads. I D threads look*  
*flapped holes*  
*flapped and no pitting evident. Metal still sound under flaps*
